Manhole Inspection Summary

Manhole # S17OO1044MH

Location Address: **2301 WINEBERRY TERR**

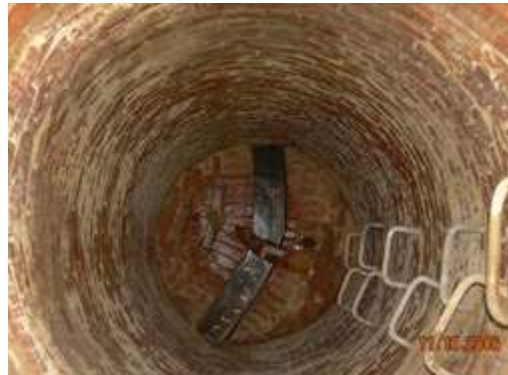
Top View

Bench and Channel debris.

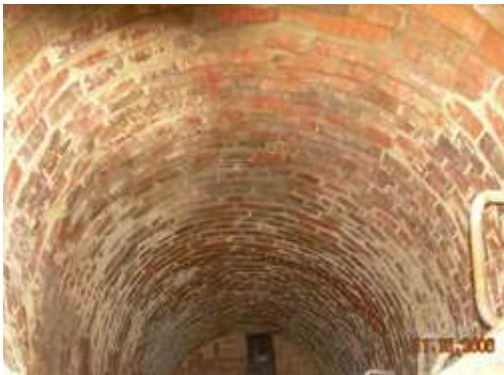
Defect

Frame leaks. Adjustment, Corbel and Barrel infiltration - other side.

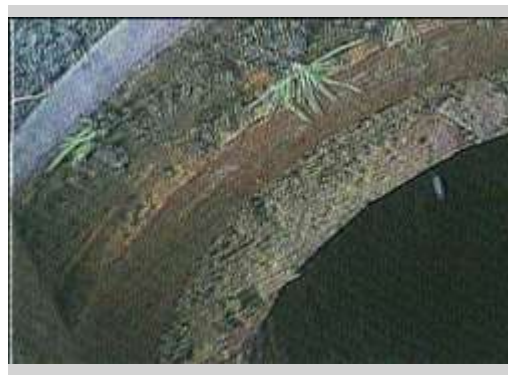
Defect

Frame offset. Frame leaks.

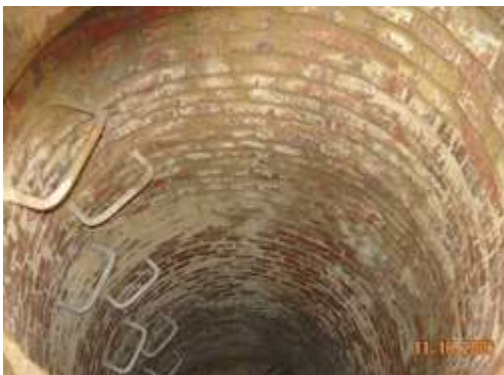
Defect

Frame leaks. Adjustment, Corbel and Barrel infiltration.

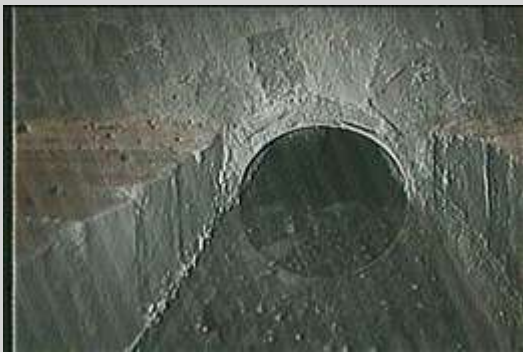
8 in. Circular Gravity Sewer Pipe Out @ 12 O'Clock

Deposits: ☐ None ☒ **Mud** ☐ Sludge ☒ **Debris** ☒ **Grease**

Silt Depth: **2** (in.) Deposits Extent: **Medium**

Infiltration: **Evidence** Pipe Seal Cond: **Cracked**

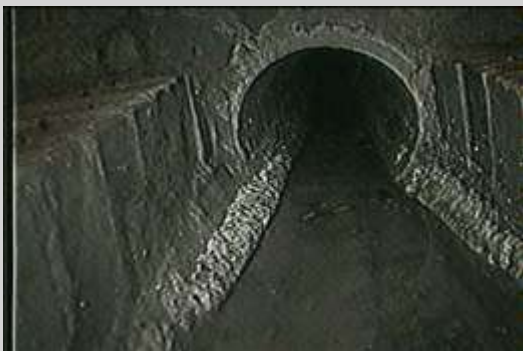
8 in. Circular Gravity Sewer Pipe In @ 7 O'Clock

Deposits: ☐ None ☒ **Mud** ☐ Sludge ☐ Debris ☒ **Grease**

Silt Depth: **0.5** (in.) Deposits Extent: **Light**

Infiltration: **Evidence** Pipe Seal Cond: **Cracked**
